# SORELL HERITAGE SURVEY

| Address: Shark Point Road Sorell 7172 | | UPI: 2901147 | PID: 0 |
| Name: COOPER'S BARN | | | |

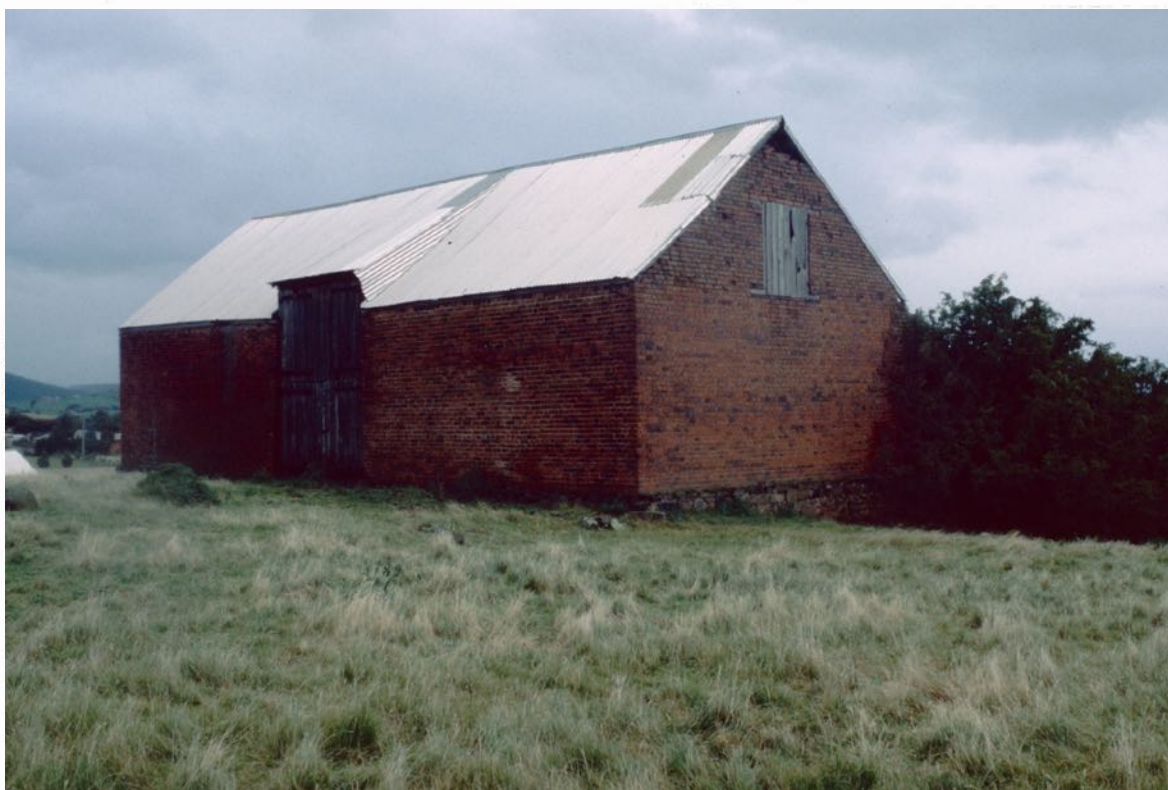
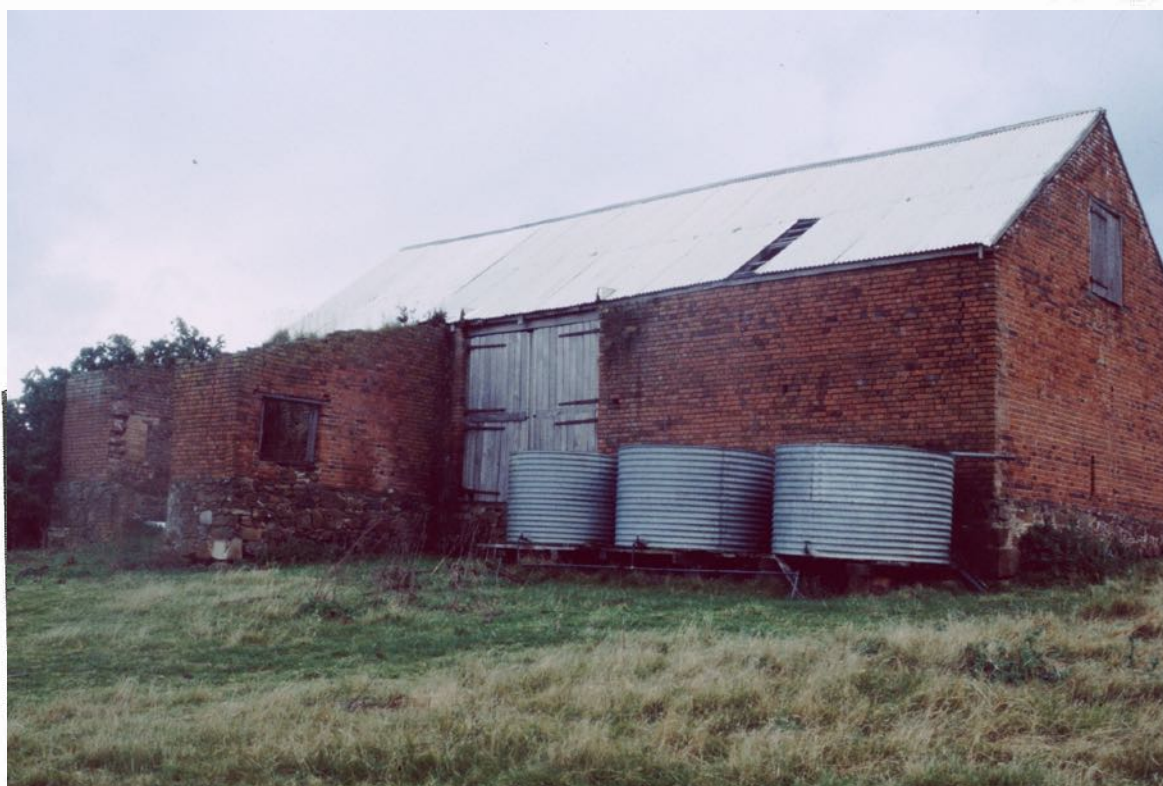
COOPER'S BARN

This is a brick barn built on stone foundations with a gabled cgi roof. It measures approximately 16 metres X 7 metres and has double timber doors with a raised roof section over them. There is a high door in the eastern gable. There are no gutters and the top wall plate appears to be pit sawn.

There is a brick skillion roofed lean-to on the south side - now roofless.

There is damage to the top of the western brick gable (bricks missing). One piece of the roofing iron is missing on the south side.

The brackets and hinges to the main doors are hand forged.
