# SORELL HERITAGE SURVEY

| Address: Nugent Road Nugent 7172 | | UPI: FBI37 | PID: 0 |
| Name: RINGAROOMA | | | |

# SORELL HERITAGE STUDY

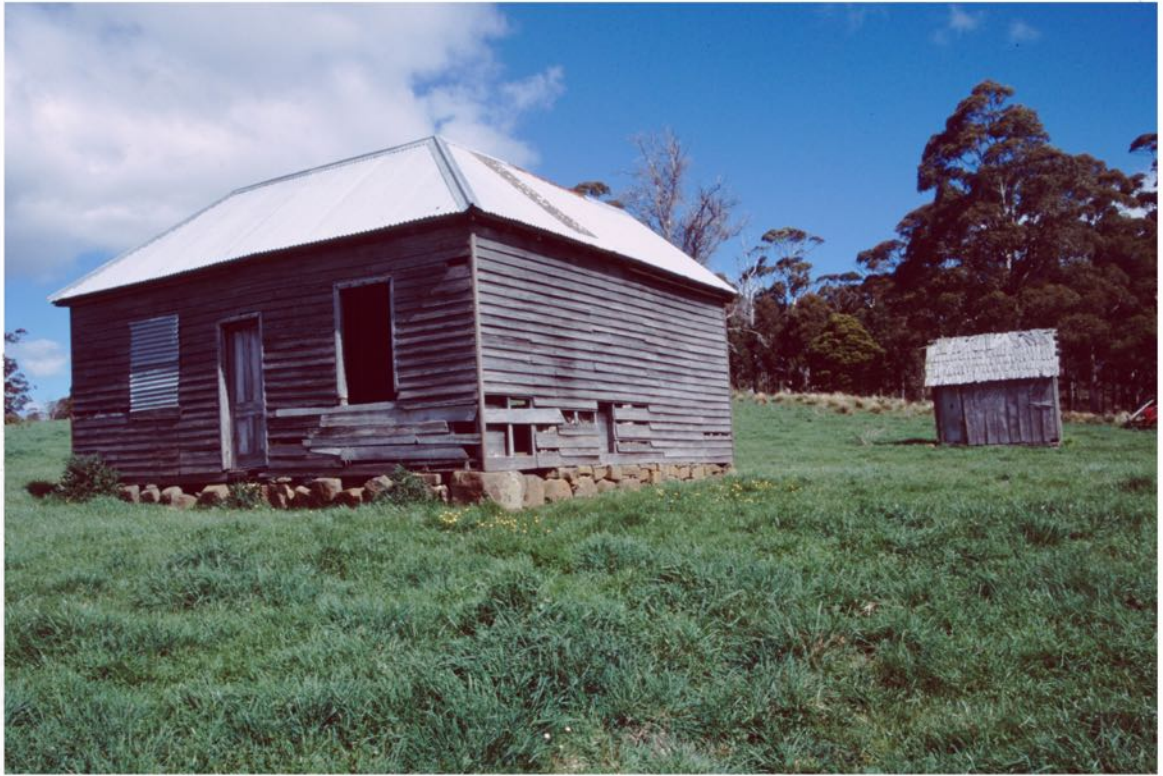
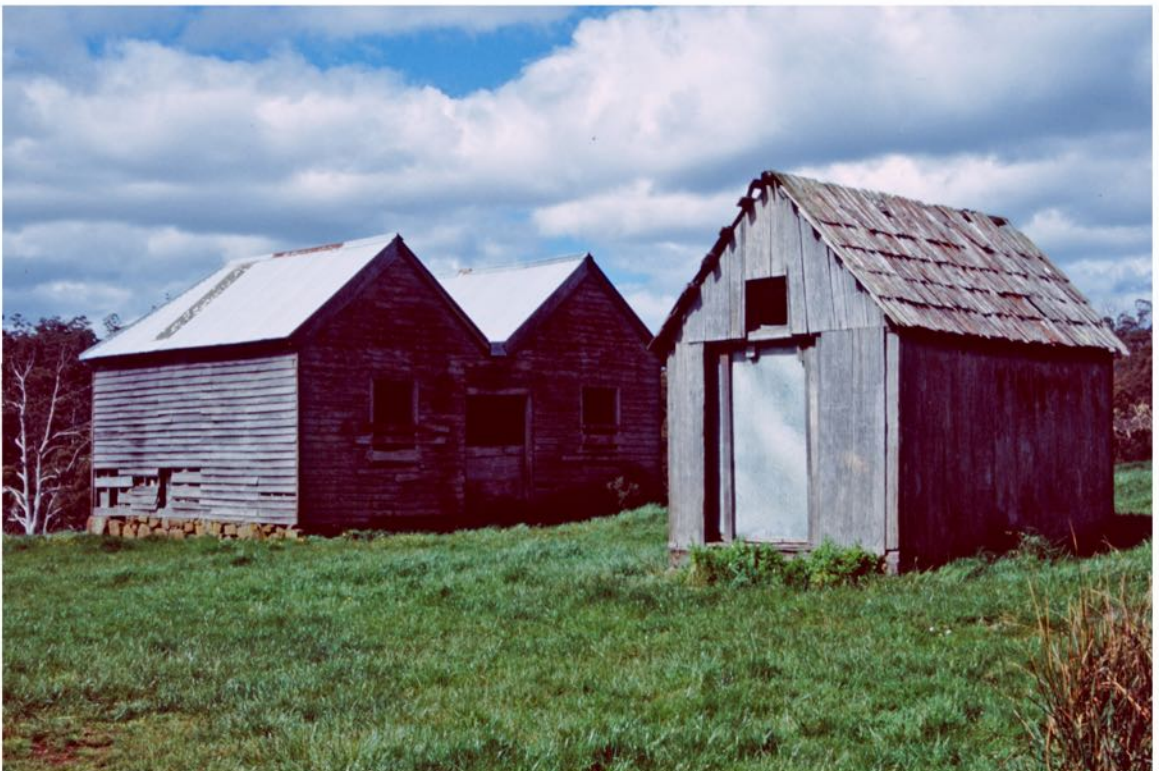
RINGAROOMA

| Condition: | Deteriorated | | |
| Integrity: | Disturbed or damaged | | |

A derelict weatherboard cottage with a corrugated iron roof which is hipped at the front and features twin parallel gables at the rear. The construction features split rafters and door frames and rose-headed nails. It has a four panelled main door although other windows and doorways have been altered. The interior is lined with Baltic pine and there are shingle battens under the corrugated iron roof. The interior of the cottage has been substantially altered with part of it being used as a shearing shed for a number of years.

To the rear there is a small slab creamery with a shingled roof and tin lining. All structural elements in the building are split rather than sawn with some of the cladding slabs of very wide dimensions. The creamery also contains the concrete on which the separator was once installed.

The house and creamery should be included in Schedule 3 of the Sorell Planning Scheme.
